**NORTH POND DAM  
CT 00450**

**NORTH POND DIKES  
CT 00681**

**PHASE I INSPECTION REPORT  
NATIONAL DAM INSPECTION PROGRAM**

AUGUST, 1979

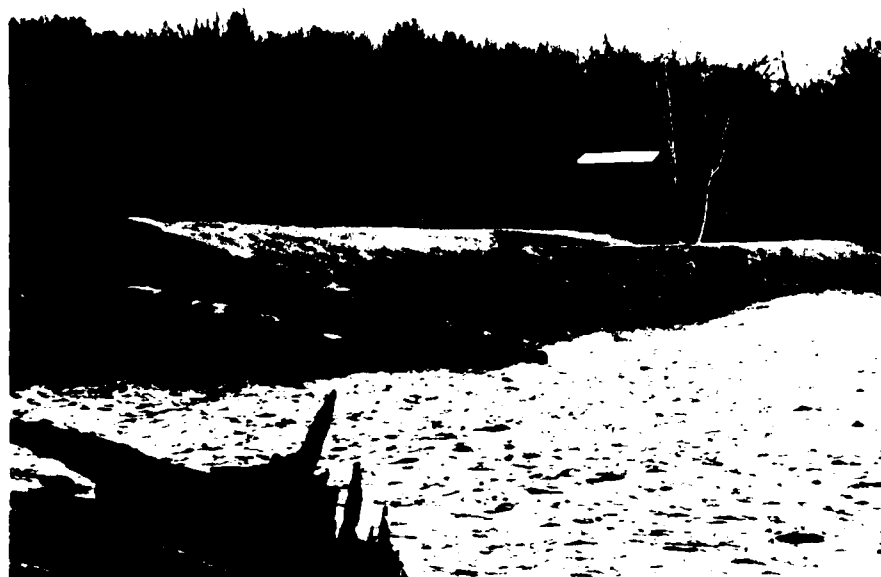
Upstream Slope - The upstream slope of the dam is protected by riprap to about three feet from the crest (Photo 2). The riprap is in good condition and there is a well-maintained grass cover on the slope above the riprap.

Between the spillway and the embankment is a stone masonry training wall which consists of two walls side by side. The left wall is lower and forms a sill between the spillway and the higher wall adjacent to the embankment (Photo 4). There is a small seep at the base of the wall as located on Sheet B-1 and shown in Photo 5. The higher wall rises approximately eight inches above the embankment and some minor erosion is occurring on the upstream and downstream slopes of the dam adjacent to the wall. The upstream end of the wall has deteriorated probably as a result of ice pressures (Photo 2).

6. Deterioration of the dam spillway training wall could continue and worsen, as could erosion of the embankment slopes adjacent to the training wall.

Photo 2 - General view of upstream slope from left end.  
Note deterioration of upstream end of spillway  
training wall (April 1979)

4. The upstream end of the spillway training wall should be repaired.
5. The seepage through the dikes should be closely monitored for increase in flow or sediment content. Monitoring should include photographic records for future reference.
